**South Portland High School
Renovation & Addition Plan
November 2, 2010 – Referendum Vote**

Accreditation

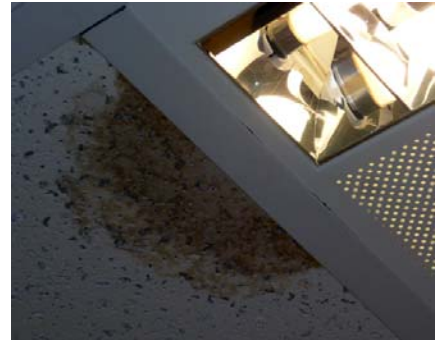
Figure 1 - Bathroom leakage from above

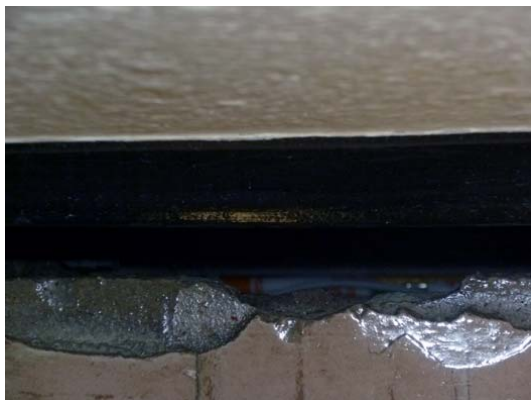
Figure 2 -Floor of Annex separating from structural wall – one of several structural cracks
