**South Portland High School
Renovation & Addition Plan
November 2, 2010 – Referendum Vote**

Building Structure & Systems Deficiencies

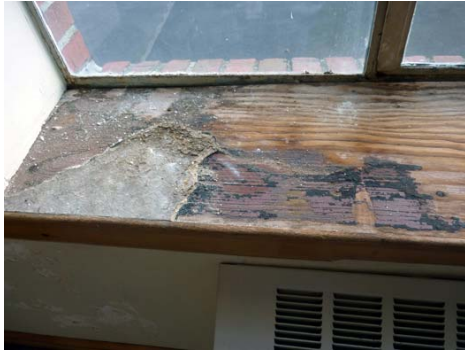
Figure 1 - Single pane window wall - leaks & energy inefficient

- Weak building envelope – infiltration of water and heat escape make it extremely energy inefficient – very costly to operate – little, if any, insulation in existing window walls.
- Building lacks a ventilation system.
- The heating system has long outlived its' expected life.
- Beal gym operating systems are outdated, especially the locker room plumbing.

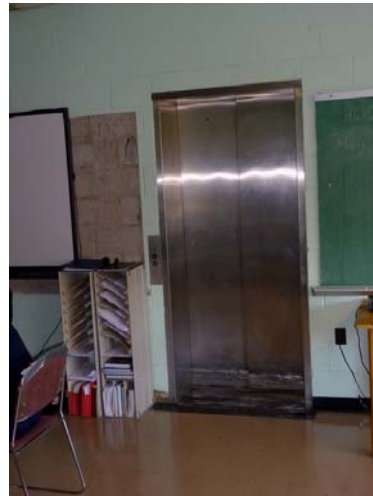
Figure 2 - Elevator opens into classroom

- The many level changes in the North Annex create barriers for people with physical handicaps making day-to-day use challenging for students, staff, and community members.

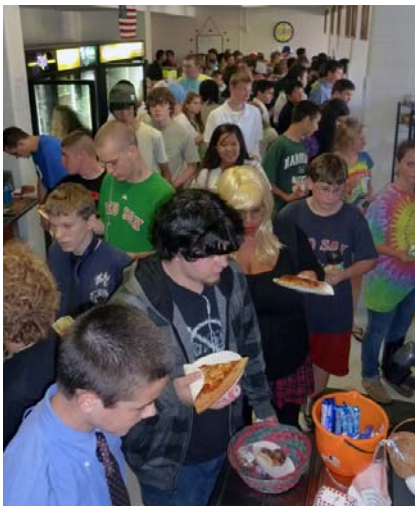
Figure 3 - Congested Serving Line

- Congestion within insufficient serving spaces causes crowded lunch conditions.
- In general, the existing building systems are well past their normal life spans, and need to be replaced in full.
- Delivery truck access currently causes air and noise pollution into classrooms. These classrooms are located adjacent to and above the delivery route for food to the cafeteria, and paper goods / materials from central receiving.
- The existing bathrooms do not meet ADA (Americans w/ Disabilities Act) criteria; the plumbing lines are corroded and leak frequently.
